Stone Avenue and Grant Road Water Quality Assurance Revolving Fund (WQARF) Site Feasibility Study (FS) and Proposed Remedial Action Plan (PRAP), Updates, and Next Steps 4/28/20

Community Advisory Board (CAB) Meeting

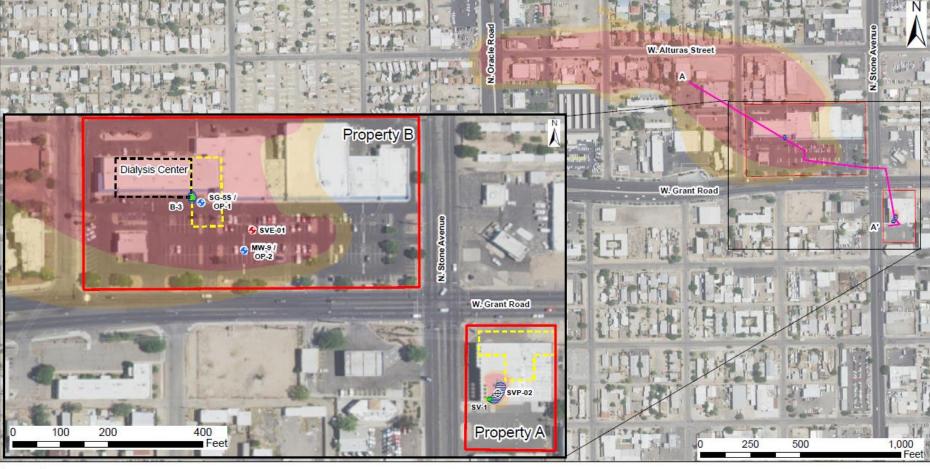
Figure 3

Site Remediation Areas Stone Avenue and Grant Road WQARF Site Tucson, Arizona

Dedicated and Temporary sampling locations depicted on this figure are those specifically discussed in Section 2.3 of the FS.

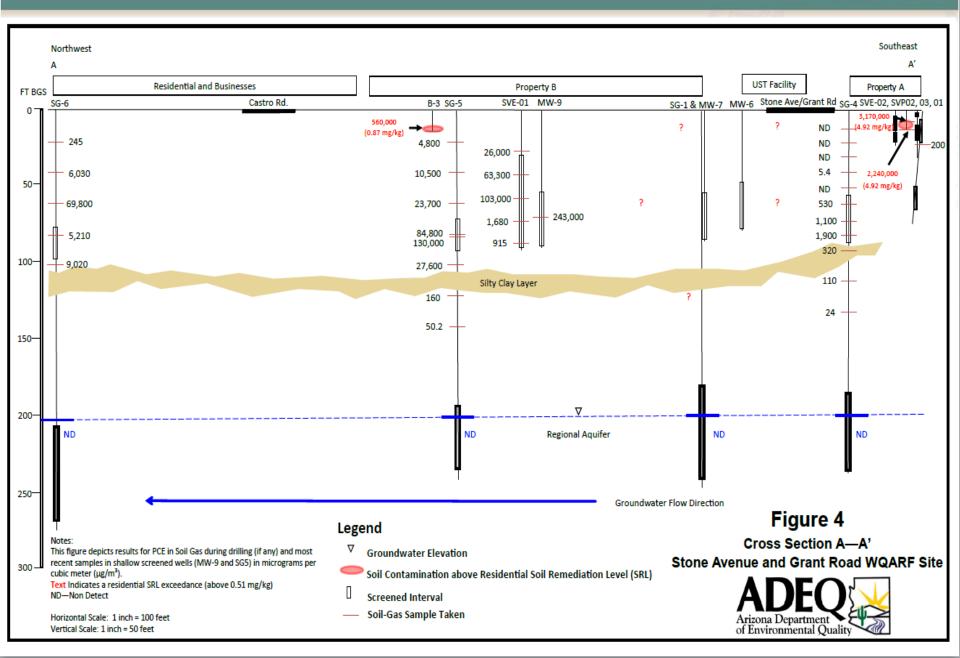
Vertical Extent

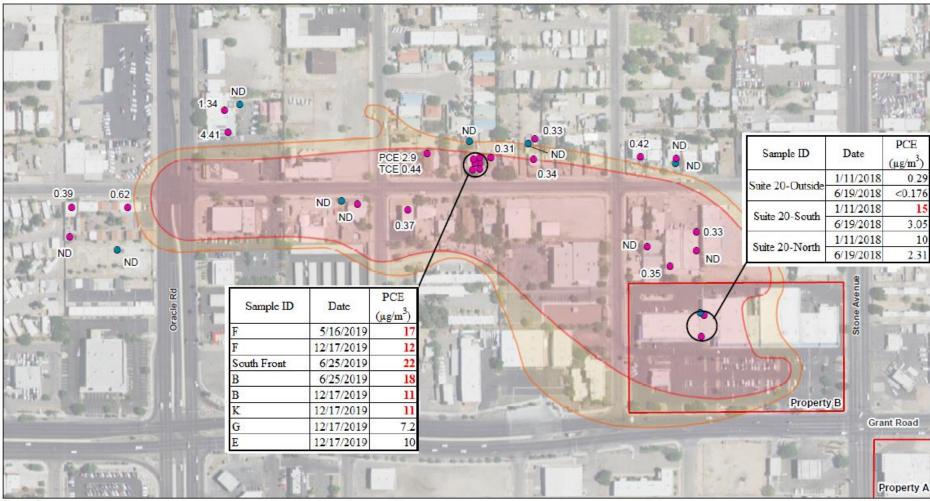
Figure 6

Map depicts the maximum PCE concentration detected at each sampling location and TCE only where detected. All units are in micrograms per cubic meter (µg/m²)

All units are in micrograms per cubic meter (µg/m²) Indoor Air RSL = Regional Screening Level
PCE Residential RSL = 11 µg/m², Composite Worker Air RSL = 47 µg/m²
Exceedances of residential RSL are in RED.

Indoor Air Quality Monitoring for PCE Stone Avene and Grant Road WQARF Site Tucson, Arizona

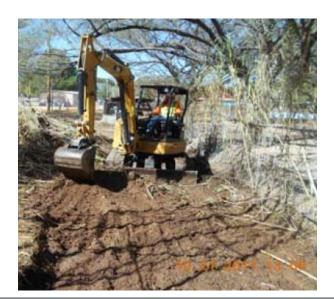
Soil Excavation

- Physical removal of contaminated soils
- Larger footprint / invasive technique
- Limitations of the Site

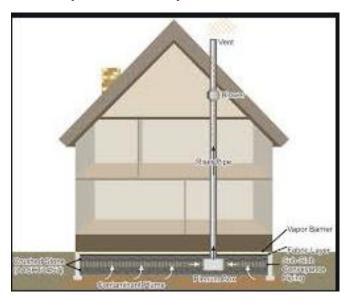
Vapor Intrusion Mitigation Systems (VIMS)

Property owner may choose to sign and agree to Environmental Access Agreements to install and maintain a residence specific system

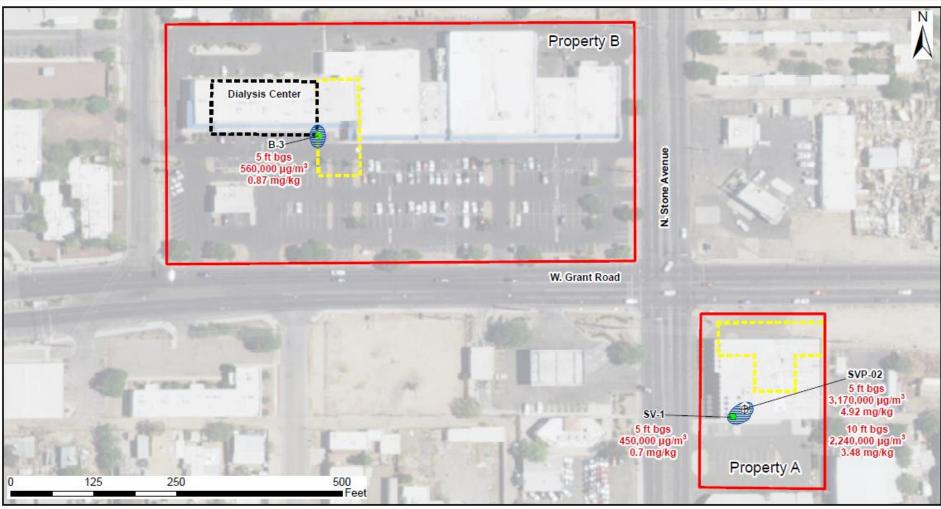
Figure 2

Site Remediation Areas Stone Avenue and Grant Road WQARF Site Tucson, Arizona

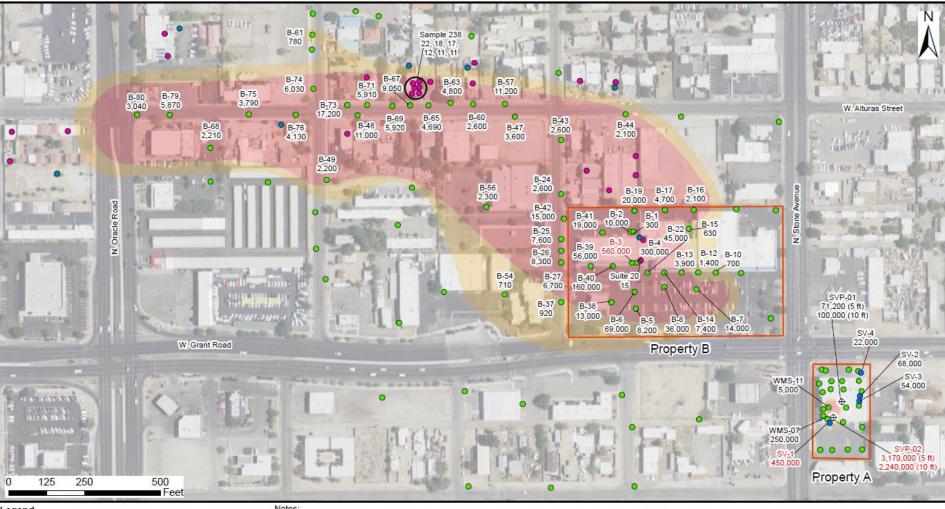
Figure 3

All PCE results are in micrograms per cubic meter (µg/m³)
Locations without labels are non detect (ND) or below respective screening levels.
Text in red indicates residential SRL exceedance (above 0.51 mg/kg).
Residential Indoor Air RSL - 11 µg/m³
Composite Worker Air RSL - 47 µg/m³
RSL - Regional Screening Level

Screening Level Exceedances in Shallow Soil-Gas and Indoor Air Stone Avenue Grant Road WQARF Site Tucson, Arizona

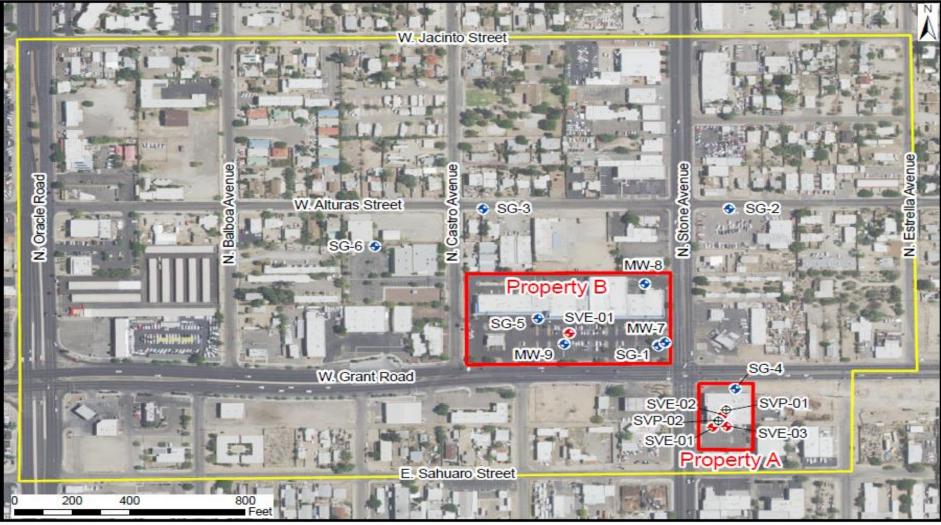
Figure 4

Monitoring Locations Stone Avenue and Grant Road WQARF Site Tucson, Arizona
